Reliability of Lead-Free Interconnections under Consecutive Thermal and Mechanical Loadings

T.T. MATTILA¹ and J.K. KIVILAHTI^{1,2}

1.—Laboratory of Electronics Production Technology, Helsinki University of Technology, 02150 Espoo, Finland. 2.—E-mail: Jorma.Kivilahti@hut.fi

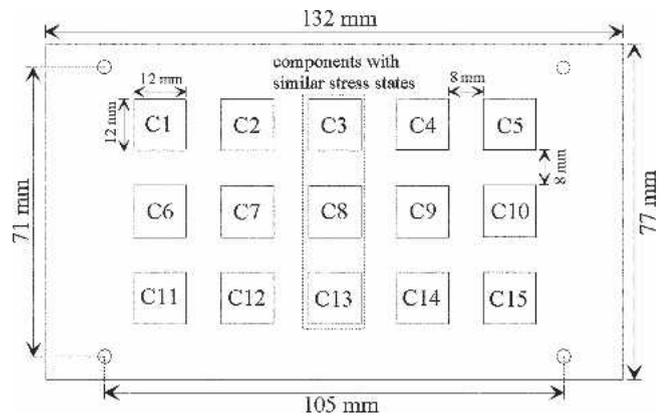
Fig. 1. Layout and dimensions of the drop test board.

The high-density build-up multiplayer (1 + 6 + 1, FR4) PWBs were manufactured by Aspocomp Group (Salo, Finland) with two different protective coating options on the copper soldering pads: Ni(P)|Au [Ni: 2 μ m; immersion Au: ~0.02 μ m; and 9 wt.% P in Ni] and OSP (0.2–0.5 μ m). The test board shown in Fig. 1 was designed according to the JEDEC board level drop test standard (JESD22-B111).²⁰

In order to make use of as many data points as possible in the reliability analysis, the three middle components, C3, C8, and C13 in Fig. 1, were pooled to form a single sample per test board. The difference in the drops to failure on the three component locations was studied separately for both the coating options with the use of the Wilcoxon rank-sum test, and no significant differences could be found. To validate the pooling of component locations, the maximum longitudinal strains during the impact at different component locations were calculated by the finite element method and verified experimentally.¹¹ The average drops to failure with standard deviations are shown in Fig. 2.

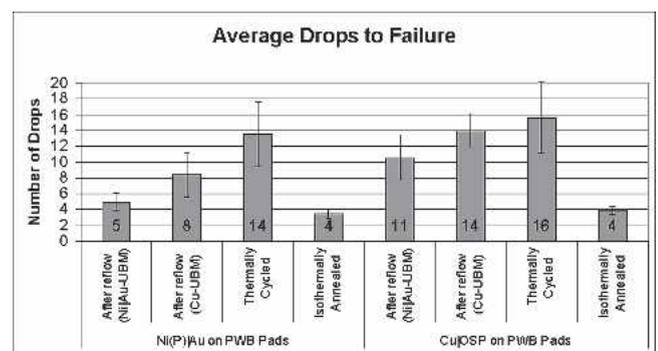
Fig. 2. Average drops to failure with standard deviations.

Table I presents the Weibull parameter estimates of the drop-tested samples. The difference in the η values cannot be tested statistically and therefore the reliability performance must be compared based on the average drops to failure (Fig. 2). Based on the Shapiro-Wilk Test for normality, the drops-to-failure data did not comply with the normal distribution and therefore the significance must be tested with nonparametric methods. In engineering sciences, the statistical confidence levels of more than 95% typically can be considered sufficient to reject the null hypothesis, and therefore all the tests in this paper are carried out at less than 5% risk level (α).

The effect of the thermal cycling on the drop test reliability was studied by making use of the 2^2 full-factorial design and the Wilcoxon Rank-Sum Test. The diagram in Fig. 2 shows an increase in the number of drops to failure when the thermal cycling treatment is carried out before the drop test, but the difference was not statistically significant ($\alpha = 19.3\%$). The reason for this is the relatively large dispersion in the drops to failure of the thermally cycled assemblies. The effect of PWB metallization was also not statistically significant.

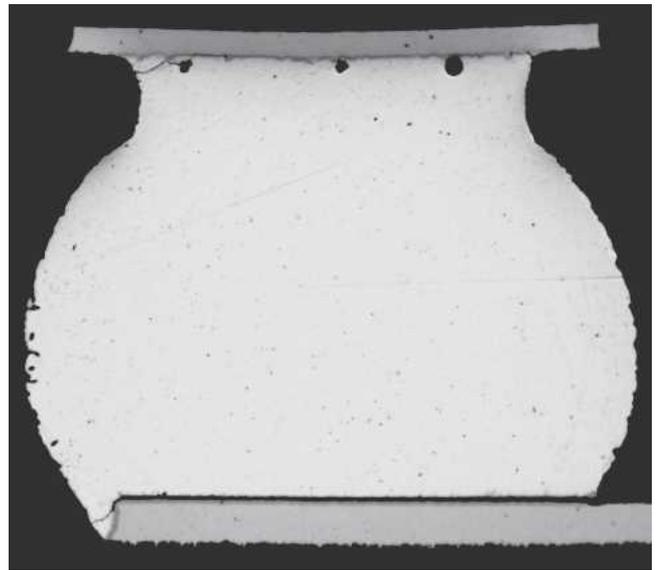
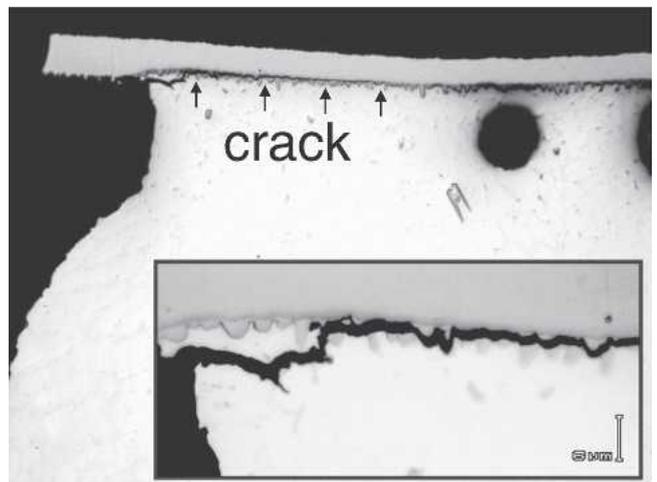
Fig. 3. Failure mode (1) of the as-soldered interconnections on (a) Ni(P)|Au: brittle intermetallic fracture through the reaction layers between the Ni(P) and the bulk solder, and (b) Cu|OSP: fracture through the Cu_6Sn_5 reaction layer.

The failure analyses revealed that cracking of the reaction layers on either side of the interconnections was the primary failure mode (failure mode (1)). Regardless of the component-side metallization interconnections on the Ni(P)|Au metallized boards failed at the PWB side exhibiting cracking of the brittle reaction layers between the Ni(P) metallization and the bulk solder (Fig. 3a). The reasons for the inferior reliability performance of the Ni(P)|Au PWB coating have been discussed in more detail elsewhere.^{12,13} The solder interconnections on the Cu|OSP coated PWBs failed at the component side, where cracks propagated through the $(\text{Cu},\text{Ni})_6\text{Sn}_5$ or the Cu_6Sn_5 reaction layer depending on the component UBM: $(\text{Cu},\text{Ni})_6\text{Sn}_5$ on the Ni|Au metallization and Cu_6Sn_5 on the copper metallization (Fig. 3b). The reason for this failure mode is that, under fast deformation rates, the flow stress of the solder is increased and stresses concentrate at the corner regions of the interconnections where the fracture strength of the intermetallic reaction zone is exceeded.¹²

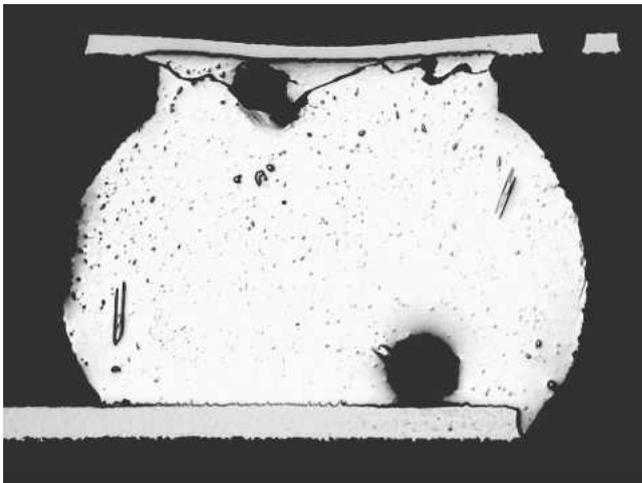
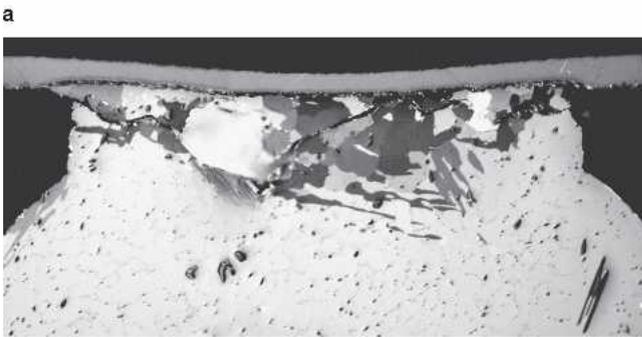
a
b
Fig. 4. Intergranular fracture through the bulk of the solder in thermally cycled interconnection (failure mode 2).

It is interesting, however, that the failure mechanism has changed from that observed in the interconnections drop tested in the as-soldered state. In addition, the failure mode was the same regardless of the board-side metallization. The failure mechanism has changed from the brittle fracture through the intermetallic layers to intergranular fracture through the bulk of the solder. The cracks often propagate entirely in the bulk solder through the interconnection (failure mode (2)) but sometimes only partially propagate in the bulk solder and afterward move into the intermetallic compound layers (failure mode (3)). The cracks typically locate on the component-side “neck region” of the interconnections (Fig. 4a).

Figure 4b shows the image taken with polarized light from the same interconnection from which the bright light image in Fig. 4a is taken. The reflection of the polarized light is dependent on the grain orientation of the surface, and therefore the different colors in the images represent different orientations. Figure 5 shows that when the network of high-angle boundaries is no longer available, the cracks grow further in the intermetallic layers between the metallization and the solder owing to strain rate hardening. Thus, when the assemblies have been thermally cycled, the drop test reliability is dependent on the extent of recrystallization in addition to the strain-rate hardening.

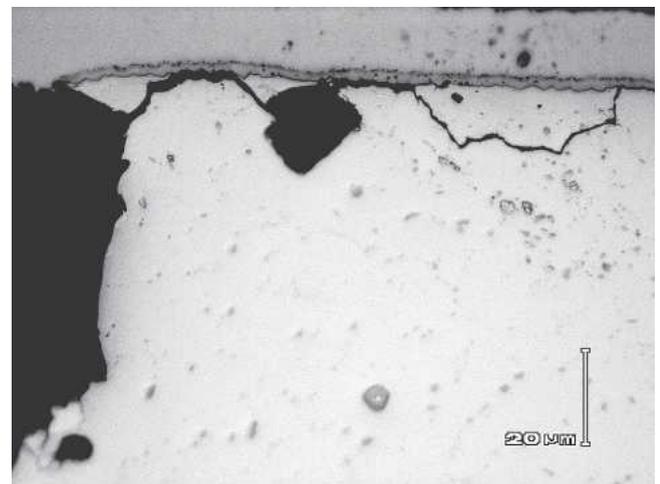
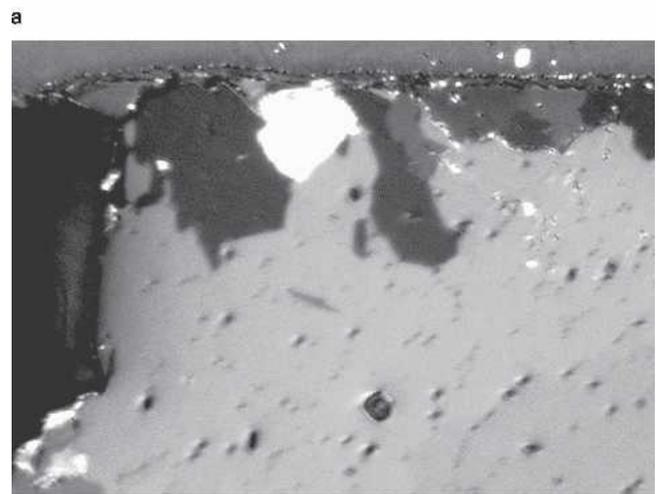
a
b
Fig. 5. A change from intergranular fracture to brittle intermetallic fracture as the grain boundaries are no longer available (failure mode 3).

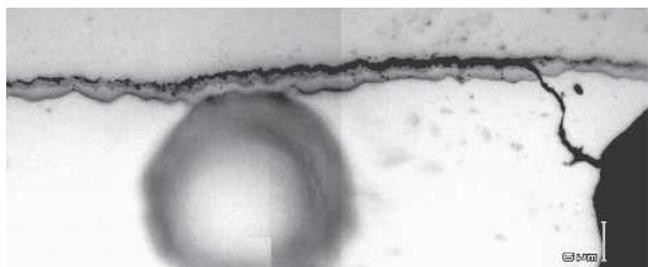
Fig. 6. Fracture through the voids inside the Cu_3Sn in the isothermally annealed interconnection (failure mode 4).
