## Impact of Inherent Design Limitations for Cu–Sn SLID Microbumps on Its Electromigration Reliability for 3D ICs

*Published in:*  
IEEE Transactions on Electron Devices

# Impact of Inherent Design Limitations for Cu–Sn SLID Microbumps on Its Electromigration Reliability for 3D ICs

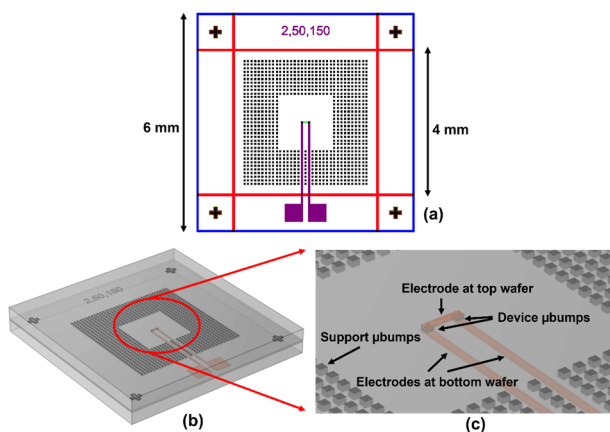
**Fig. 2.** (a) Layout of the chip with a two-bump test structure. Violet traces are the contacts on the bottom wafer, and green traces are the contacts on the top wafer. Bottom and top wafers are bonded through the bumps (black), (b) 3D schematic of the bonded chip, and (c) zoomed-in 3D schematic of the two-bump test structure.

Various test structures, such as two bumps, daisy chain, and kelvin structures, were incorporated in the 4-in mask process. The  $\mu$ bumps were designed to be square in shape with the lateral dimensions ranging from 10 to  $100 \mu\text{m}$ . A two-bump test structure was employed for this study. The advantage of this test structure is that the current flow from both top to bottom chip and bottom to top chip could be investigated with focus on just two  $\mu$ bumps. Fig. 2(a) shows the mask layout of the two-bump test structure along with the dimensions of the top and bottom chips. The bottom chip dimensions were  $6 \text{ mm} \times 6 \text{ mm}$ , and the top chip dimensions were  $4 \text{ mm} \times 4 \text{ mm}$ . The scribe lines used to dice the bonded chips are shown in red (partial cut) and blue (through cut).

The partial cuts denote the locations where only the top chip was diced to expose the Cu contact pads on the bottom chip for probing. The through cut denotes the locations where both top and bottom chips were diced. An array of support  $\mu$ bumps were also provided to mitigate the stress formed during the dicing process. Fig. 2(b) and (c) shows the 3D schematic of the bonded chip highlighting the device  $\mu$ bumps, support  $\mu$ bumps, and top and bottom Cu traces. In this work, the two-bump test structures, which were investigated, were of two lateral dimensions, i.e., 25 and 50  $\mu$ m.

As can be seen from Fig. 2, the device bumps are at the middle of the chip. To assess it for cross-sectional imaging, the chips were first cut in two parts along a horizontal outline at the vicinity of the device  $\mu$ bumps ( $\approx 300 \mu\text{m}$  away) with a femtosecond laser micromachining tool. A femtosecond laser has now been widely used for destructive analysis, which generates negligible laser-induced damage to the samples [13]. The cut chips were then molded into epoxy and cured for subsequent grinding and polishing steps, which was carried out using standard metallographic methods.

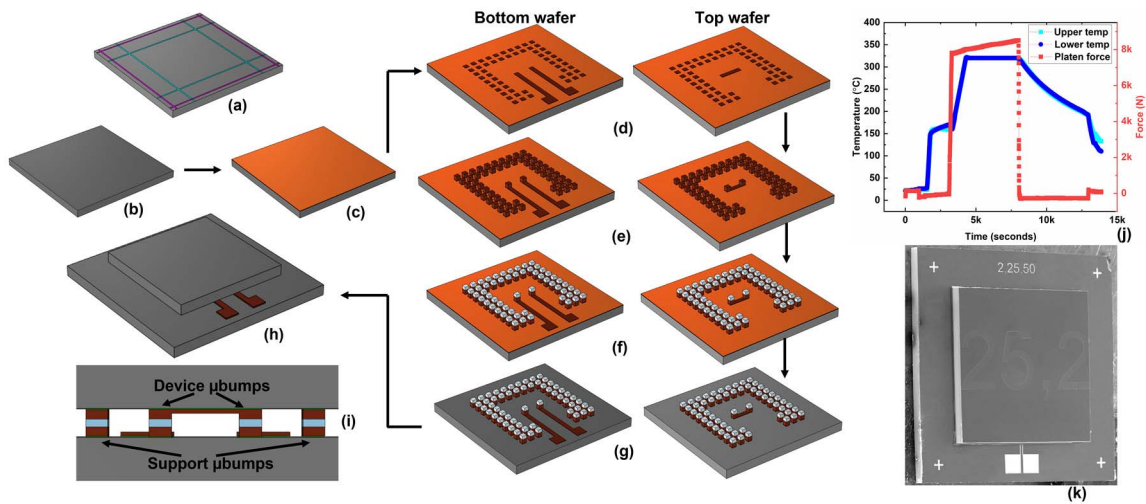
**Fig. 3.** (a) Back side patterning for scribe lines, magenta for bottom wafer (through cut), and cyan for top wafer (partial cut—only top wafer), (b) front side Si wafer, (c) TiW/Cu deposition, (d) patterning and electrodeposition of Cu electrodes on bottom and top wafers, (e) patterning and electrodeposition of Cu bumps, (f) electrodeposition of Sn bumps, (g) etching of Cu seed layer and TiW, (h) wafer bonding and dicing, (i) cut plane across the chip showing the Cu (brown)— $\text{Cu}_3\text{Sn}$  (blue)—Cu (brown) bond line, (j) wafer bonding process profile, and (k) SEM image of the as-fabricated chip.

The fabrication of the test structures is a four-mask process. It starts with a pair of 4-inch double-sided polished (DSP) 100-orientated Si wafer. In the first step, the back-side patterning was carried out on the wafer pair, wherein the alignment marks and scribe lines were patterned using optical lithography and etched with reactive ion etching (RIE) tool with  $\text{SF}_6$  as an etching gas for both bottom and top wafers, Fig. 3(a). A 15 nm of titanium tungsten (TiW) adhesion layer and a 100 nm of Cu seed layer were then sputter deposited on the front side of both the wafer pairs, Fig. 3(b) and (c). The front side of the wafer pair was then patterned to form the traces, contact pads, and support  $\mu$ bumps using an AZ15nXT (450 CPS) negative photoresist. The patterned wafer pair was treated with an oxygen plasma with an  $\text{O}_2$  flowrate of 30 mL/min and an RF power of 100 W for 3 min to improve the wettability of the surface before electroplating. A 1  $\mu$ m of Cu was then electroplated at a current density of 15 mA/cm<sup>2</sup> with NB SEMIPLATE CU 100 after which the resist was stripped, Fig. 3(d). Then, the device  $\mu$ bumps and the support  $\mu$ bumps were subsequently patterned using the same photoresist and treated with the oxygen plasma as described before. Subsequently, 4  $\mu$ m of Cu (NB SEMIPLATE CU 100) and 2.5  $\mu$ m of Sn (NB SEMIPLATE SN 100) were electroplated at a current density of 15 and 10 mA/cm<sup>2</sup>, respectively, Fig. 3(e) and (f). After every electroplating step, the thickness was confirmed by a contact profilometer at five different locations

After stripping the resist, the final patterning was done with the photoresist to protect the Cu traces and device  $\mu$ bumps during the etching step of the Cu seed layer and TiW adhesion layer. Cu was etched in a commercial etchant Cu etch 150 purchased from NB technologies GmbH, and TiW was etched in an  $\text{H}_2\text{O}_2$  solution heated at 60 °C, Fig. 3(g). The etching of Cu and TiW layers was visually confirmed under an optical microscope before stripping the resist. Finally, the wafer bonding process was carried out in an Applied Microengineering Limited (AML) wafer bonder. The wafers were mounted on the top and bottom platens, and the chamber was pumped down to  $\approx 1e-6$  bar. The wafers were preheated to 150 °C before bringing them into contact. After alignment of the wafers, a force of 8 kN ( $\approx 20$  MPa, total bonding area—4 cm<sup>2</sup>) was applied on the platens, and the temperature was ramped up to 320 °C at a ramp up rate of 10 °C/min. The bonding was then carried out for 1-h duration, after which the temperature was ramped down. Finally, the bonded wafer pairs were diced along the through and partial cut scribe lines on a DAD3220 dicer tool from Disco, Fig. 3(h). Fig. 3(i) shows the schematic of the bond line, Cu–Cu<sub>3</sub>Sn–Cu. Fig. 3(j) shows the platen force and temperatures versus time from the wafer bonding process. A good match was there between the temperatures of the upper and lower platens. Fig. 3(k) shows the scanning electron microscopy (SEM) image of the final fabricated chip.

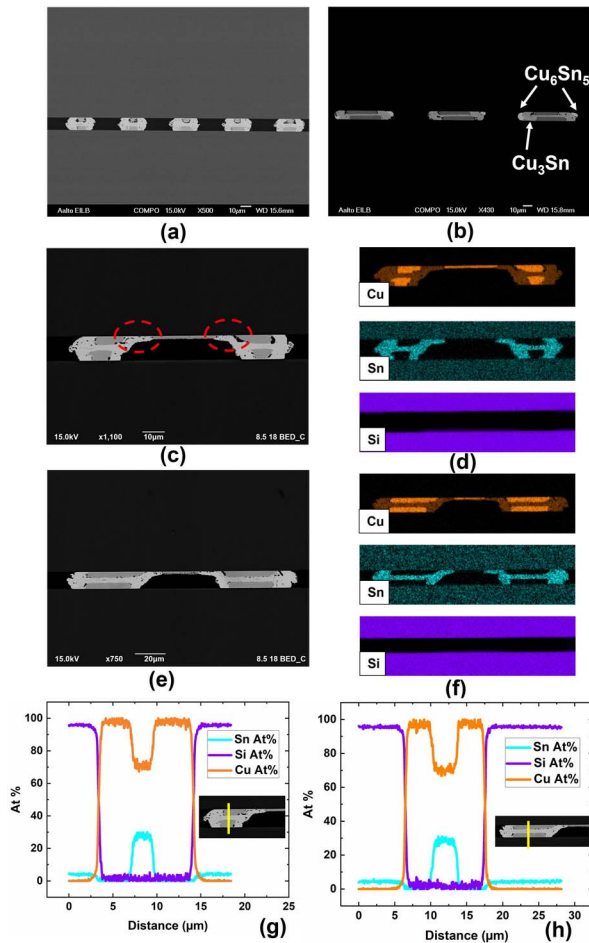
Fig. 4. (a) SEM image of 25- $\mu\text{m}$  support bumps, (b) SEM image of 50- $\mu\text{m}$  support bumps, and (c) SEM image of 25- $\mu\text{m}$  two-bump test structure.  $\text{Cu}_3\text{Sn}$  formed due to Sn squeeze out at the upper Cu trace is shown in red circle, (d) EDS elemental maps of the 25- $\mu\text{m}$  test structure, (e) SEM image of 50- $\mu\text{m}$  two-bump test structure, (f) EDS elemental maps of the 50- $\mu\text{m}$  test structure, and atomic percentage plot versus distance across the cutline shown in the inset figure for (g) 25- $\mu\text{m}$  device  $\mu\text{bump}$  and (h) 50- $\mu\text{m}$  device  $\mu\text{bump}$ .

Fig. 4(a) and (b) shows the cross-sectional SEM images of the support  $\mu$ bumps of  $25$ - and  $50$ - $\mu\text{m}$  test structures, respectively. The EDS point analysis of the  $\mu$ bumps shows that  $\text{Cu}_3\text{Sn}$  was formed in the bond line, with the atomic percentage of Cu and Sn as  $\approx 73.8\% \pm 0.3\%$  and  $\approx 26.2\% \pm 0.3\%$ , respectively. Moreover, in the support  $\mu$ bumps from  $50$ - $\mu\text{m}$  test structures, small amount of  $\text{Cu}_6\text{Sn}_5$  was observed, Fig. 4(b). It was also confirmed with the EDS point analysis with the atomic percentage of Cu and Sn as  $\approx 58.0\% \pm 1.8\%$  and  $\approx 42.0\% \pm 1.8\%$ , respectively. However,  $\text{Cu}_6\text{Sn}_5$  was not observed in the support  $\mu$ bumps from  $25$ - $\mu\text{m}$  test structures.

Fig. 4(c) and (e) shows the SEM images of the device  $\mu$ bumps from  $25$ - and  $50$ - $\mu\text{m}$  test structures, respectively.

$\text{Cu}_3\text{Sn}$  was also observed to be formed on the top Cu trace, which is due to the squeeze out of liquid Sn during the bonding process [shown in Fig. 4(c) (red circle)]. Ideally, the upper Cu trace should connect the Cu pads of the two  $\mu$ bumps, as shown in the schematic of Fig. 3(i). Fig. 4(d) and (f) shows the EDS elemental mapping of Cu, Sn, and Si on the test structures. Fig. 4(g) and (h) shows the atomic percentage plots across the cutline shown in the inset, respectively. As can be seen, full  $\text{Cu}_3\text{Sn}$  was formed in the bond line, and the atomic weight percentage of the Cu and Sn was found to be  $\approx 71.1\% \pm 1.8\%$  and  $\approx 27.2\% \pm 1.9\%$ , respectively. No  $\text{Cu}_6\text{Sn}_5$  was observed in the device  $\mu$ bumps of the test structures under consideration. The height of all the  $\mu$ bumps measured was  $\approx 11$   $\mu\text{m}$ . The total thickness of the electroplated Cu and Sn stack from top and bottom wafer was  $\approx 15$   $\mu\text{m}$ , so the reduction in thickness of the final bond line is attributed to the squeeze out of liquid Sn. Moreover, formation of voids could be seen in the test structures concentrated mostly at the Cu/ $\text{Cu}_3\text{Sn}$  interface, which is widely reported due to interplay of various parameters, such as Kirkendall voiding and impurities incorporation in the electroplated structures [14], [15].

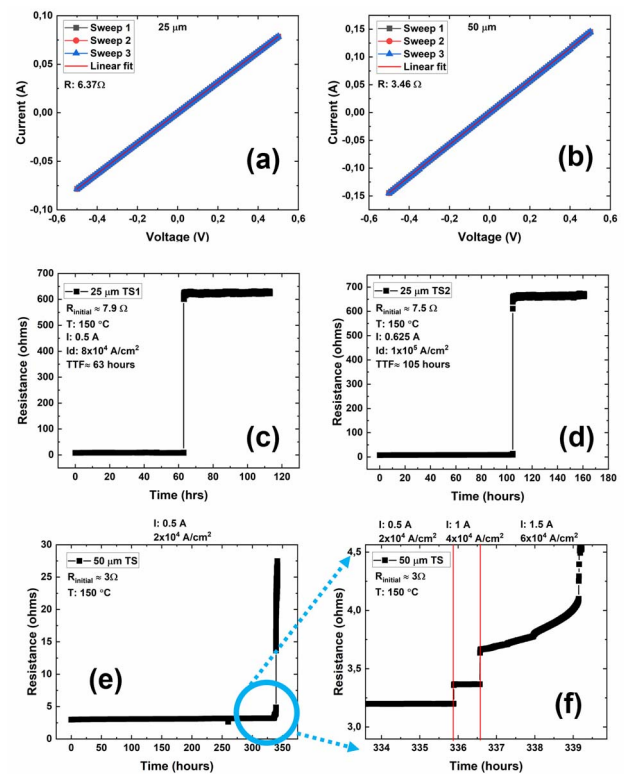
Fig. 5.  $I$ - $V$  characteristics of (a) 25- $\mu\text{m}$  test structure and (b) 50- $\mu\text{m}$  test structure, EM tests of 25- $\mu\text{m}$  test structures for a current density of (c)  $8 \times 10^4$  and (d)  $1 \times 10^5 \text{ A/cm}^2$ , and (e) and (f) EM tests of the 50- $\mu\text{m}$  test structure.

Fig. 5(a) and (b) shows the linear  $I$ – $V$  characteristics of the two-bump test structures performed before the EM tests. The resistance of the two-bump test structures measured varied from  $6$  to  $7$   $\Omega$  and  $3$  to  $4$   $\Omega$  for the  $25$ - and  $50$ - $\mu\text{m}$  test structure, respectively. Fig. 5(c) shows the EM test of a  $25$ - $\mu\text{m}$  test structure ( $25$ - $\mu\text{m}$  TS1) conducted on a thermal chuck at  $150$  °C at a current density of  $\approx 8 \times 10^4$  A/cm<sup>2</sup> (current value  $0.5$  A). The resistance was stable for  $\approx 63$  h [time to failure (TTF)] after which there was a sudden jump in the resistance value, which was stable for further  $30$  h. Fig. 5(d) shows the EM test result of another  $25$ - $\mu\text{m}$  test structure ( $25$ - $\mu\text{m}$  TS2)

conducted at 150 °C and at a current density of  $\approx 1 \times 10^5 \text{ A/cm}^2$ . In this case, the resistance was stable for  $\approx 105 \text{ h}$  before the failure.

For the 50- $\mu\text{m}$  test structure (50- $\mu\text{m}$  TS), for the current level of 0.5 A, the current density corresponds to  $\approx 2 \times 10^4 \text{ A/cm}^2$ . At this current density, the resistance was observed to be stable for  $\approx 336 \text{ h}$  (approximately two weeks), and no failure was recorded, Fig. 5(e) and (f). The current density was then increased to  $\approx 4 \times 10^4 \text{ A/cm}^2$  and monitored for  $\approx 40 \text{ min}$  during which the resistance was again stable. The small increase in the base resistance because of increase in current could be attributed to the Joule heating, which increased the measured resistance value. Subsequently, the current density was increased to  $\approx 6 \times 10^4 \text{ A/cm}^2$  (current—1.5 A), and the resistance was observed to gradually increase after which the test was terminated.

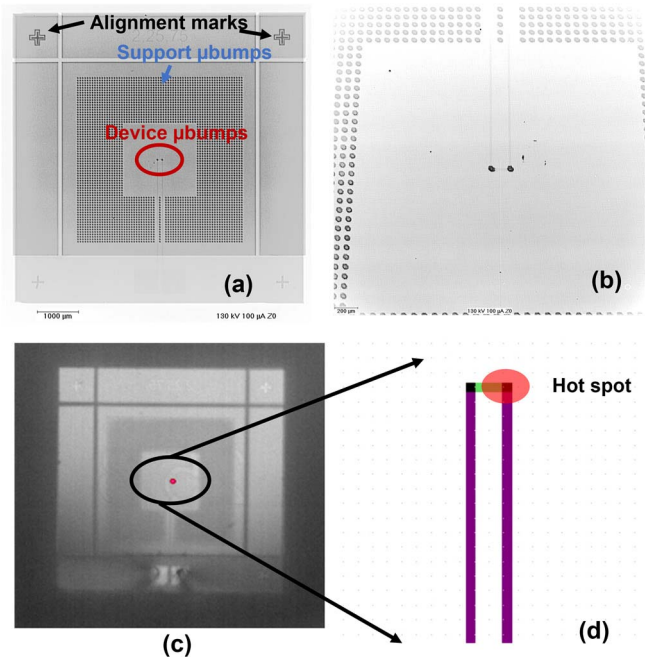
Fig. 6. (a) 2-D X-ray image of 25- $\mu\text{m}$  TS1 chip with the device  $\mu\text{bumps}$  and support  $\mu\text{bumps}$  marked, (b) zoomed-in image of the device  $\mu\text{bumps}$  with tilt, (c) LiT thermal image of the chip showing the hot spot, which indicates probable failure location, and (d) schematic showing the location of the hot spot in (c).

Fig. 6(a) shows the image of an entire chip, where device  $\mu$ bumps and support  $\mu$ bumps are marked. The alignment marks at the top corners (left and right) demonstrate good alignment of the top and bottom chips. Fig. 6(b) shows the zoomed-in image of the device  $\mu$ bumps. Two limitations were recognized: 1) small size—the size of the bumps was  $\approx 25 \mu\text{m} \times 25 \mu\text{m} \times 11 \mu\text{m}$ , which is too low for effective analysis and 2) the device  $\mu$ bumps were surrounded by the support  $\mu$ bumps, which makes the full 3D image construction of the device  $\mu$ bumps challenging.

On the other hand, LiT demonstrated effectiveness in locating the failure spots. The applied voltage during the LiT tests was set to 8.5 V at a frequency of 2.5 Hz, and the thermal image was acquired after 46 cycles. Fig. 6(c) shows the infrared (IR) thermal image of EM stressed sample for 25- $\mu\text{m}$  test structure (25- $\mu\text{m}$  TS1) of which the EM test result is shown in Fig. 5(c). The hot spot corresponding to the probable failure location near the device  $\mu$ bumps is clearly visible.

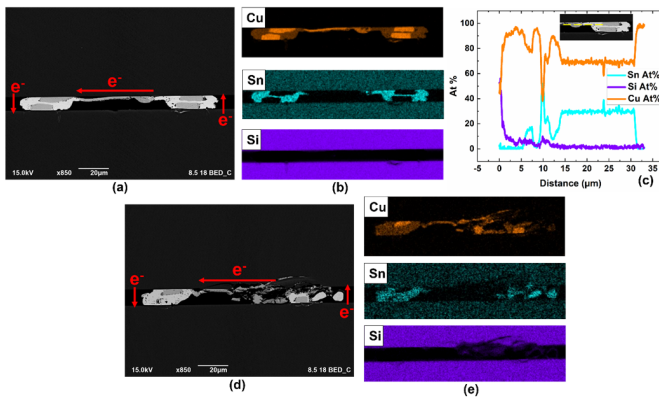
Fig. 7. (a) SEM image of EM tested 25- $\mu\text{m}$  TS1 for a current density of  $8 \times 10^4$  A/cm<sup>2</sup> with the electron current direction shown, (b) corresponding EDS elemental maps, (c) atomic percentage plot versus distance across the cutline shown in the inset, (d) SEM image of EM tested 25- $\mu\text{m}$  TS2 for a current density of  $10^5$  A/cm<sup>2</sup> with the electron current direction shown, and (e) corresponding EDS elemental maps.

2) *Destructive Failure Analysis (FIB)*: A destructive analysis was carried out to explore the probable failure locations in detail. Fig. 7(a) and (b) shows the SEM and elemental EDS mapping of the device  $\mu$ bumps from 25- $\mu\text{m}$  TS1, which was EM tested [Fig. 5(c)] and on which the LiT analysis was performed [Fig. 6(c)]. Cu traces were found to be delaminated near the location where hot spot was observed. Due to delamination, the dissipation of Joule heating gets affected, which results in hot spot formation adjacent to those locations. On the other hand, accumulation of Cu was observed on the Cu trace near to the right bump, Fig. 7(a). Fig. 7(c) shows the EDS line scan generated from the cutline shown in the inset. With closer analysis of the line scans, diffusion of Sn into the Cu trace due to EM could be suspected. The diffusion of Sn in the direction of electronic current at higher temperatures has also been widely reported in the literature for solder bumps [16].

Fig. 7(d) and (e) shows the SEM and elemental EDS mapping of 25- $\mu\text{m}$  TS2 sample, which was tested at a current density of  $\approx 1 \times 10^5$  A/cm<sup>2</sup> [Fig. 5(d)]. As can be seen

from the elemental maps, complete burnout and melting of  $\mu$ bump and silicon were observed in the right bump. Also, delamination [similar to Fig. 7(a)] and cracking of upper Cu trace were observed near the left bump. However, no detailed information could be extracted regarding the initiation and mechanism of failure, as the tests continued for almost  $\approx 55$  h after the failure [Fig. 5(d)].

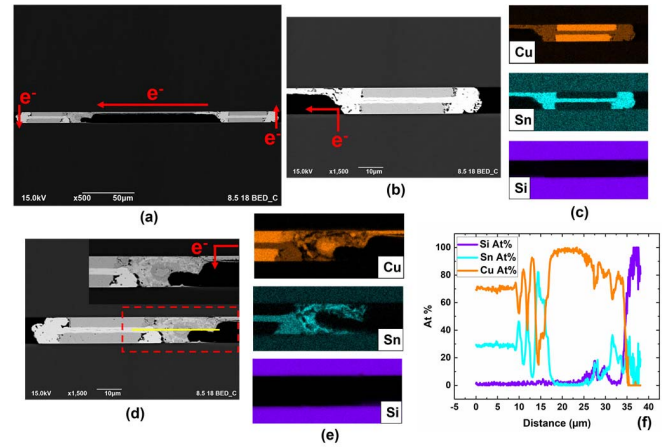
Fig. 8. (a) SEM image of EM tested 50- $\mu\text{m}$  TS with the electron current direction shown, (b) zoomed-in SEM image of the right bump and (c) corresponding EDS elemental maps, (d) zoomed-in SEM image of the left bump and (e) corresponding EDS elemental maps, and (f) atomic percentage plot versus distance across the yellow cutline shown in (d).

Fig. 8(a) shows the SEM image of the 50- $\mu\text{m}$  TS for which the EM test is shown in Fig. 5(e) and (f). The EM tests were terminated when sudden increase in the resistance was observed at a current density of  $\approx 6 \times 10^4$  A/cm<sup>2</sup>. Fig. 8(b) and (c) shows the zoomed-in SEM image of the right bump and elemental EDS maps, respectively. No failure spots were observed at this location. In contrast to the 25- $\mu\text{m}$  test structures [Fig. 7(a) and (d)], the right bump is fully intact. This could be due to the lower current density (even for max— $6 \times 10^4$  A/cm<sup>2</sup>) because of the  $4\times$  increase in the cross-sectional area as compared with 25- $\mu\text{m}$  test structures. Fig. 8(d) and (e) shows the SEM image and the elemental maps of the left bump, respectively. From the mapping result, a segregation of Cu and Sn could be observed in the Cu<sub>3</sub>Sn layer near the upper Cu trace, which indicates local melting, as no thermodynamically stable phase could be identified from Cu–Sn system phase diagram with respect to the measured Cu–Sn atomic percentages. Fig. 8(f) shows the atomic percentage plots versus distance across the yellow cutline shown in Fig. 8(d). At the middle of the bump, the composition indicates Cu<sub>3</sub>Sn but clearly deviates and shows irregular Cu- and Sn-rich regions. Since the region that was originally Cu<sub>3</sub>Sn is supposed to be EM-resistant and thermally stable until 676 °C, observation of these kind of failures has not been reported before.

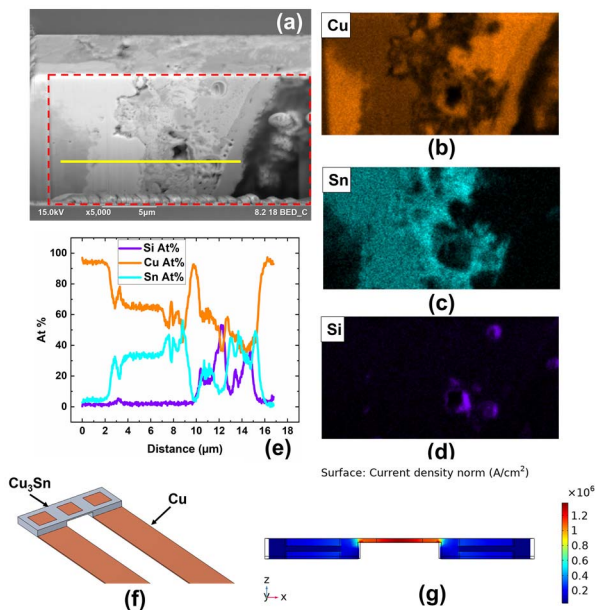
**Fig. 9.** (a) SEM image after FIB cut of the failure location, elemental maps for (b) Cu, (c) Sn, (d) Si, (e) atomic percentage plots across cutline shown in Fig. 8(a), (f) model schematic of the two-bump test structure, and (g) current density distribution across a cut plane midway of the test structure.

Then, FIB milling was carried out to examine the region underneath the surface of the failure location. Fig. 9(a)–(d) shows the SEM image after FIB cut and the corresponding elemental map data for Cu, Sn, and Si. The Cu- and Sn-rich regions also penetrate beneath the surface. Interestingly, silicon was also found to be incorporated in traces at the

failure location. Fig. 9(e) shows the EDS line scan across the yellow cutline shown in Fig. 9(a), which confirmed the presence of silicon. Although the current density across the 50- $\mu\text{m}$  bumps is lower than 25- $\mu\text{m}$  bumps ( $4\times$  cross-sectional area difference), the current density across the upper Cu trace of 50- $\mu\text{m}$  test structure is higher than the Cu trace of 25- $\mu\text{m}$  test structure ( $2\times$  cross-sectional area difference) for the maximum current of 1.5 A. Furthermore, even though the EM tests were conducted at 150  $^{\circ}\text{C}$ , the actual temperature near the  $\mu\text{bumps}$  at the current crowding zone could be much higher due to Joule heating [3]. As a result, the resistance at the current crowding zone would further increase, ultimately resulting in thermal runaway. This would then result in the local melting of  $\text{Cu}_3\text{Sn}$  and dissolution of Si in the melt with subsequent solidification after the tests are terminated.

To assess the current density levels, the 50- $\mu\text{m}$  two-bump test structure was constructed in the finite element (FE) model in COMSOL by accounting the  $\text{Cu}_3\text{Sn}$  formation due to Sn squeeze out across the Cu bumps, Fig. 9(f). Here,  $\text{Cu}_3\text{Sn}$  formation fully encloses the Cu bump to mimic the experimental observation. The electrical conductivities of Cu and  $\text{Cu}_3\text{Sn}$  were taken as  $58.1 \times 10^6$  and  $11.2 \times 10^6$  S/m, respectively. Fig. 9(g) shows the current density distribution for a current of 1 A across a cut plane from the center of the two-bump test structure. The current density is an order of magnitude higher near to the location where failures were observed as compared with the current density in  $\mu\text{bumps}$ . Moreover, the resistivity of  $\text{Cu}_3\text{Sn}$  is also higher than Cu, which also worsens the scenario due to Joule heating at the current crowding locations resulting in thermal runaway. This shows that  $\text{Cu}_3\text{Sn}$  though it is thermally stable until 676  $^{\circ}\text{C}$ , such kind of failures could also occur, underlining the importance of proper designing of
