## The Assembly of Roof Structures in the Mediaeval Churches of Finland : The Case of Karjaa Church (1470)

*Published in:*  
International Journal of Wood Culture

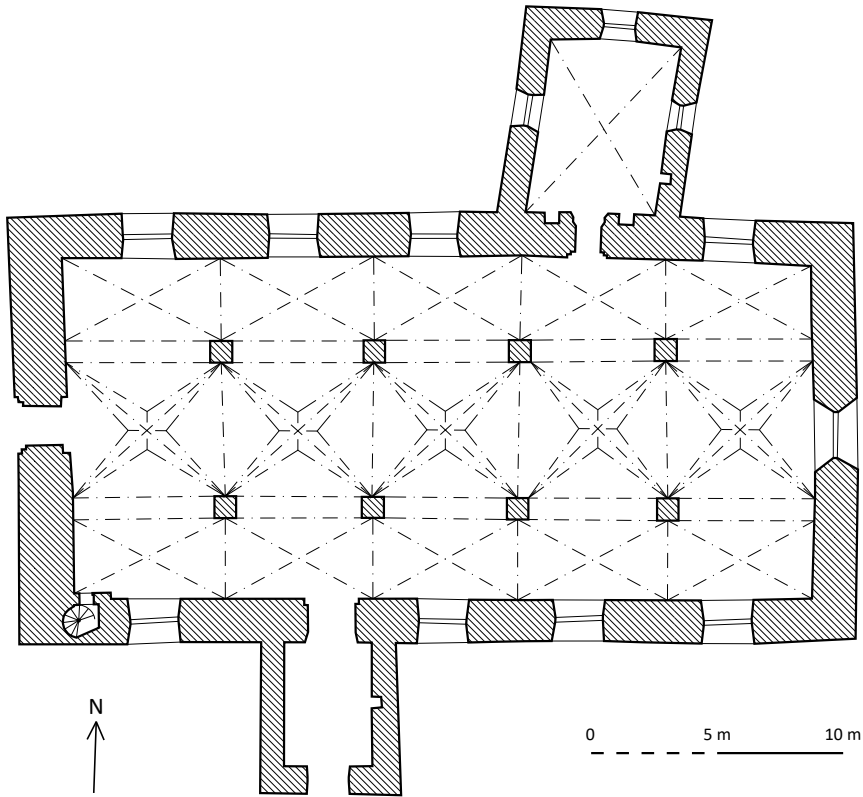
FIGURE 3 The layout of Karjaa Church with the porch on the south side of the nave and the sacristy on the north

Karjaa Church closely resembles other Finnish mediaeval churches built between the 1410s and 1550s. The nave has been laid out in an east–west direction with the altar in the east (Fig. 3). The chancel is equal in height and width to the nave and was originally separated from it with a wooden partition which no longer exists. The sacristy is in a separate wing of the building, located on the north side of the nave, close to the chancel, whereas the porch is on the south side, closer to the west end of the nave. The exterior dimensions of Karjaa Church's nave are approximately 33 metres by 17 metres. It is somewhat

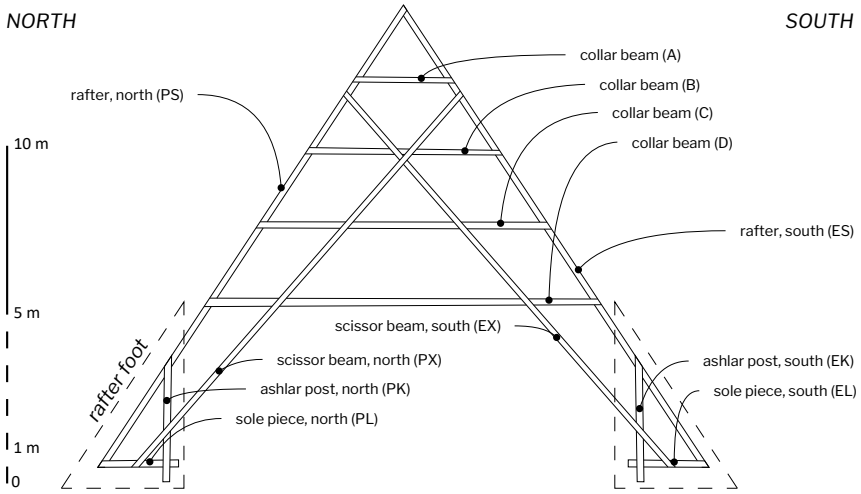
FIGURE 4 The roof trusses of Karjaa Church comprise rafters, rafter feet, scissors and four collar beams. The letter codes are largely based on the Finnish language names of the structural members

The roof trusses in the nave of Karjaa Church represent a type specifically designed to function without tie beams, adapted to accommodate masonry vaults that rise above the wall-plate level. This so-called Gothic roof truss type prevailed in Finland from the mid-15th century onwards (Fig. 4). The roof trusses are likely to be mostly made of Scots pine (*Pinus sylvestris*). The roof structure of the nave comprises 29 trusses which are spaced approximately 1.2 metres apart. Joints in the roof trusses are simple doweled lap joints, without notches or dovetail. The dowels are made of coniferous timber, whilst the roof trusses are connected by longitudinal beams and oblique ties. Sturdy planks serve as the underlay of the shingle roof. Simultaneously, the planks bind the trusses together to form a structural whole. At both ends of the nave, the outermost roof trusses are part of the church's gable facades. The second trusses from both ends stand at the inner edge of the end walls and are visible in the attic.

For the purpose of documentation, the trusses were numbered, starting from the east, and the structural members of the trusses were given symbols consisting of letters (Fig. 4). In this way, each part and joint of the roof structure could be assigned a unique code consisting of letters and numbers. Hundreds of these codes were printed on pieces of cardboard and pinned to the structures, which was crucial for the accuracy of documentation. As the researchers conducted a comprehensive photographic documentation, the printed structural codes were included in the photographs, which was known to be vital for later identifying the contents of the pictures.

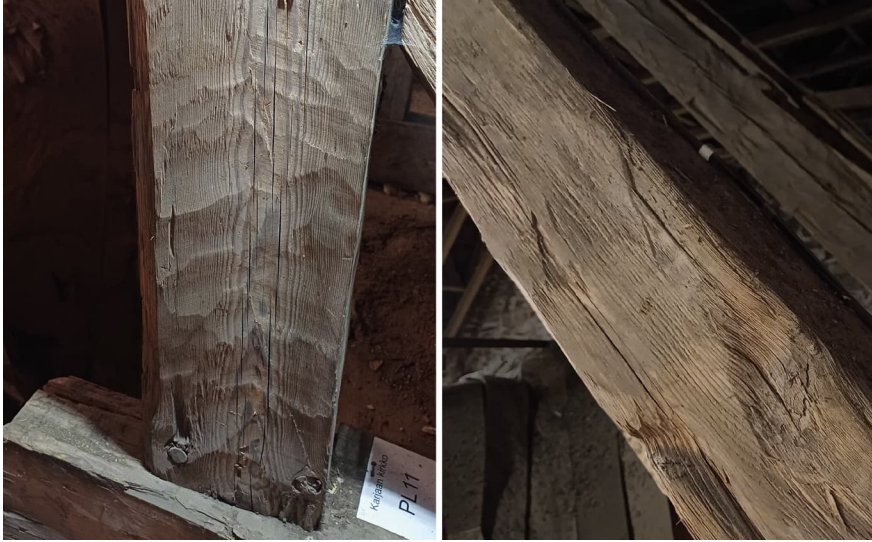
FIGURE 5 Hewing marks on an ashlar post indicate manufacturing by axe (left). The cleaved surface of a scissor beam, in some places, additionally hewn (right)  
PHOTOS BY FRANZISKA DALHEIMER (2024)

There are no signs of sawing in the roof structure of Karjaa Church, which corresponds to all known cases of mediaeval roof structures in Finland. Instead, the timbers were manufactured through the use of an axe, as evidenced by the hewing marks on the timber's surface (Fig. 5). In a few cases, mainly found in the scissor beams towards the west gable, the timber seemed to have been cleaved with an axe and wedges, and then additionally hewn in some places (Fig. 5).

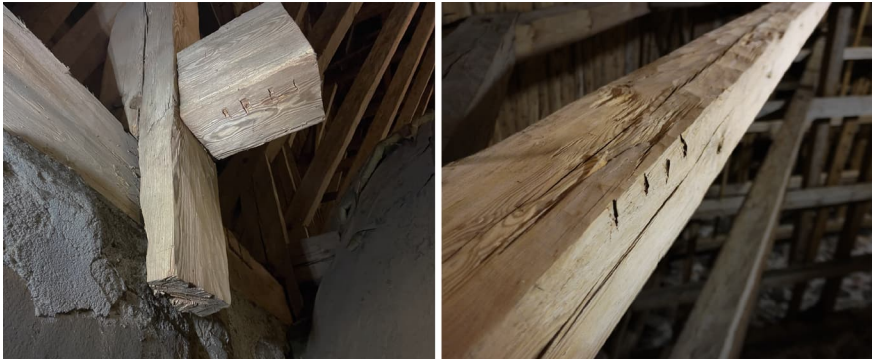
FIGURE 6 Numberings on a sole piece (left) and on a scissor beam (right). Both photographs are taken from below  
PHOTO ON THE LEFT BY LAURA LAINE (2024), PHOTO ON THE RIGHT BY MIINA TOLONEN (2020)

The roof structure of Karjaa Church is one of five mediaeval church roof structures in Finland where a numbering system of some kind has been found (Savolainen *et al.* 2023b). The numberings in Karjaa consist of small dashes measuring approximately 5 centimetres in length (Fig. 6). The markings are all made with a similar tool, probably a small axe with a narrow, thin blade. This axe would have differed from that used for hewing the timbers. Instead, it may have been the same tool employed to create starting notches for drilling the dowel holes. The numberings on the timbers had already been recorded in 2020, but, nevertheless, in 2024 we were able to find some new ones. It is also possible that some numbers still remain undiscovered. Clearly, some markings on sole pieces (PL5, PL8, PL9, PL14) had been destroyed when the sole pieces were hewn shorter in order to make room for vaults.

and one is even on a member with apparent signs of reuse. All the numberings are located on the lower side of the members, some in the middle and some on the western edge (Fig. 6). On the reused collar beam (B26) the marking is, however, on the eastern edge.

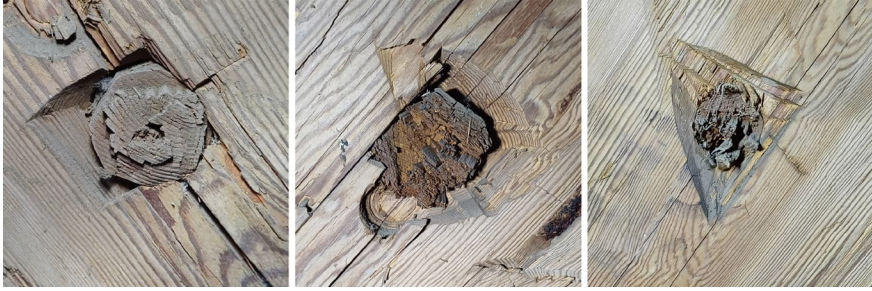
FIGURE 8 The different starting notches made before drilling the dowel holes: a square-shaped starting notch (left), a round-shaped starting notch with rather undefined edges (middle) and a triangle-shaped starting notch (right)  
PHOTOS BY FRANZISKA DALHEIMER (2024)

The holes for dowels have also been drilled from the west side. In most cases, there is a shallow notch that has likely been created to make drilling easier to start. These drilling notches have been made with a small axe, probably similar to the tool used for the numberings. The drilling notches vary in depth and in shape. They are rarely triangular and are mostly square shaped or have round, rather undefined edges (Fig. 8). The drilling notches and their shapes were documented in the rafter feet, but no clear patterns were observed. There are almost twice the number of square-shaped notches on the south side compared to the north, whilst both of the triangular notches are on the north side. However, it does not appear that any of these techniques were used for specific joints.

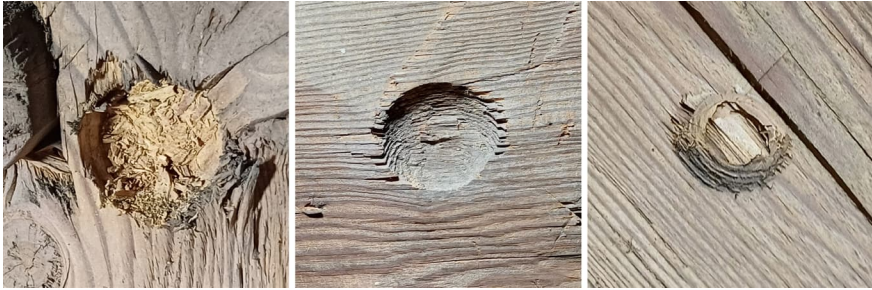
FIGURE 9 Traces of three different types of drill. The trace of a comparatively larger diameter drill (left), the drill mark of a spoon-shaped drill (middle) and the drill mark of a drill with an edge (right)

Church, incidental drill marks of different shapes were found throughout the roof structure, examples of which are shown in Figure 9. The shapes of the drill marks were documented in the rafter feet, but they formed no discernible pattern. On the south side, most marks appeared to have been made with a spoon drill, but other drill types appear to have also been used in places. On the north side, different types of drills have been used more evenly.

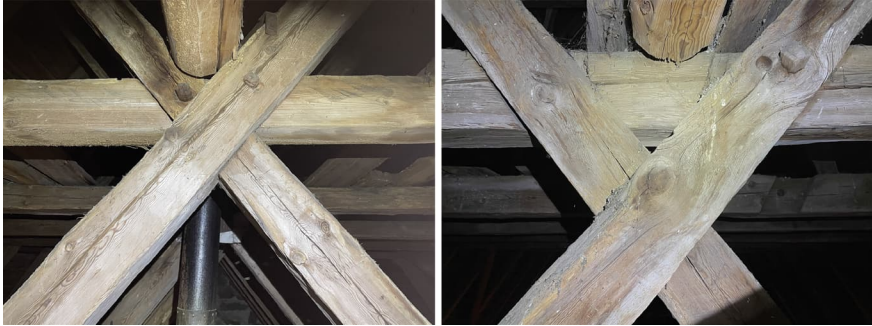
FIGURE 11 Different types of joints between scissor beams and the Collar Beam B. On the left it can be seen that there is an incidental drill mark which coincides with the dowel, but the dowel is intact  
PHOTO BY LAURA LAINE (2024)

with doveled lap joints, to the west-facing surfaces of rafters, collar beams, ashlar posts and sole pieces. As can be seen in Figure 4, the two scissor beams cross very close to Collar Beam B, creating an assembly of joints labelled xxv. In Karjaa Church, there are five different versions of this joint which are found in various trusses, as shown in Table 4. The incidental drill marks of these joints were not documented consistently, but they can be found (Fig. 11).

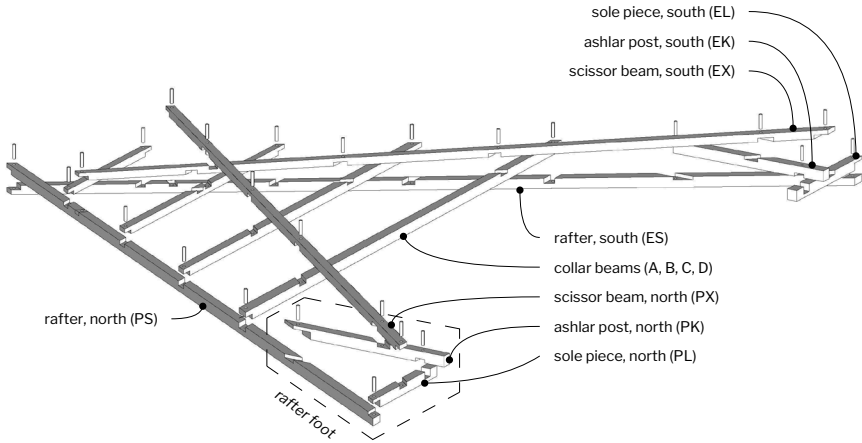
FIGURE 13 A schematic presentation of how the members in a Karjaa Church roof truss are joined together. Roof truss is laying with its west-facing side up. All the trusses in the Karjaa Church nave follow this structure, except those in the outer facades of the gables which lack collar beams as well as scissor beams  
DRAWING BY LAURA LAINE (2024)

The roof trusses of Karjaa Church have evidently been manufactured whilst lying flat, with the west-facing surface upwards, since all members of the trusses have been added from that side. Simply, the trusses have been assembled with an upper face, which has been typical of mediaeval roof trusses in Central Europe (Binding 1991: e.g. Fig. 101; Épaud 2011: p. 83) and in Sweden ever since the High Middle Ages (Gullbrandsson 2023a, 2023b), and of the preserved mediaeval roof trusses in mainland Finland. In Karjaa Church's trusses, all the incidental drill marks and the drilling notches are on the west-facing surface and all dowels are also inserted from the west. The order in which the structural members of the trusses were joined together is presented in Figure 13, and a Harris matrix of the assembly process is shown in Figure 14.

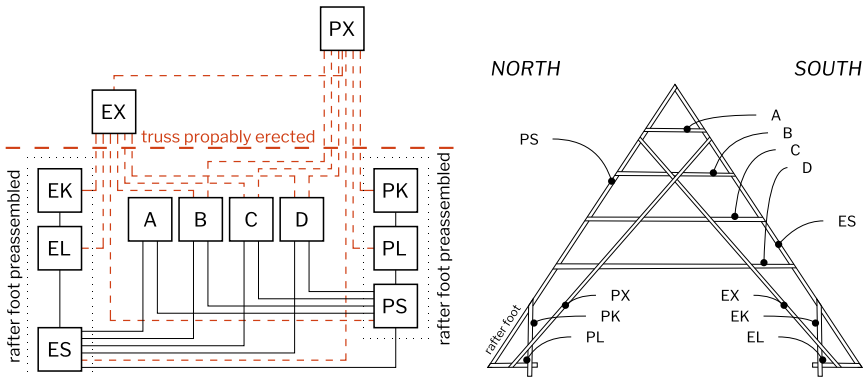
FIGURE 14 A Harris matrix of a Karjaa Church roof truss  
DRAWING BY LAURA LAINE (2024)

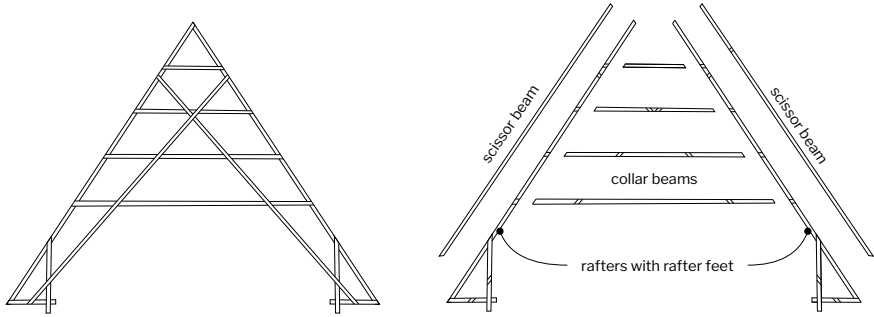
FIGURE 15 The schematic of a roof truss of Karjaa Church (left). After manufacturing the truss was dismantled into eight parts (right)  
DRAWING BY LAURA LAINE (2024)

The exact number of incidental drill marks and their relation to dowels was documented for the rafter feet, and the results were presented in the previous section (Tables 2 and 3). When the drill mark coincides with a dowel but the dowel is intact (type-a), we can infer that the joint in question has been taken apart after manufacture and later reassembled with a new dowel. Contrastingly, when the drill mark is also seen in the dowel (type-b), this indicates that the joint was assembled only once. The joints where scissor beams (X) connect with sole pieces (L) or ashlar posts (K) belong quite consistently to the former type of mark (type-a), whereas joints between rafters, sole pieces and ashlar posts mostly belong to the latter type of mark (type-b). These observations indicate that the rafter feet were kept intact after the initial assembly on the ground, whilst scissor beams were removed and lifted to the wall-plate level separately. The large size of the roof trusses makes it highly probable that the collar beams were also dismantled for transport and that the rafters were detached from each other. This assumption is supported by the presence of the type-a drill marks in the top parts of the trusses, although the survey was not comprehensive. Our conclusion, therefore, is that the trusses were manufactured in stacks on the ground, and once a stack had been completed, the next step in the process was to dismantle the trusses one by one into eight pieces (Fig. 15).

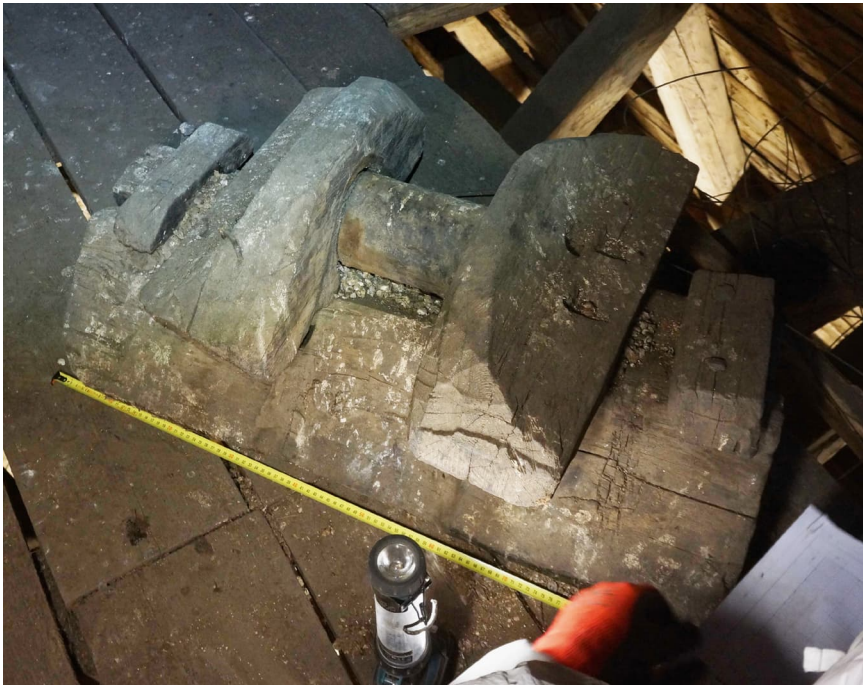
FIGURE 16 The winch found in the attic of Karjaa Church  
PHOTO BY MIINA TOLONEN (2020)

After the roof trusses were manufactured and disassembled, they had to be transported to wall-plate level — to some type of scaffolding. Ropes would have been required to hoist the heavy timbers up, but we were unable to find any preserved signs of them. The only lifting device found in the attic was a winch (Fig. 16) near the pitch of the roof, but its purpose is not known for certain. Once the pieces of a truss had been transported up, the truss would need to be reassembled. This could have been done in two different ways. On the one hand, the rafters with rafter feet already attached could have been separately lifted to an upright position and joined from the top, after which the collar beams and finally the scissor beams could be added. However, in this case the weight of the rafters would have caused them to sag,<sup>3</sup> and fitting the collar beams to their places would have become difficult. On the other hand, the truss could have been assembled in a horizontal position and then erected,
